## Bumper/Fascia Replacement with Advanced Driver Assistance Systems (ADAS)

January 2020

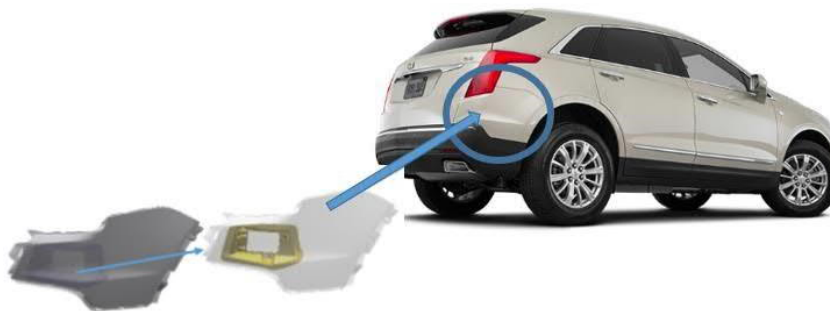
Figure 1.1

Depending on vehicle build configuration, the Bumper/Fascia system may have ADAS sensors attached to the inner surface that are not visible from the exterior of the vehicle (Please refer to Figure 1.1). GM is limiting repairs to these Bumper/Fascia systems on vehicles equipped with ADAS.

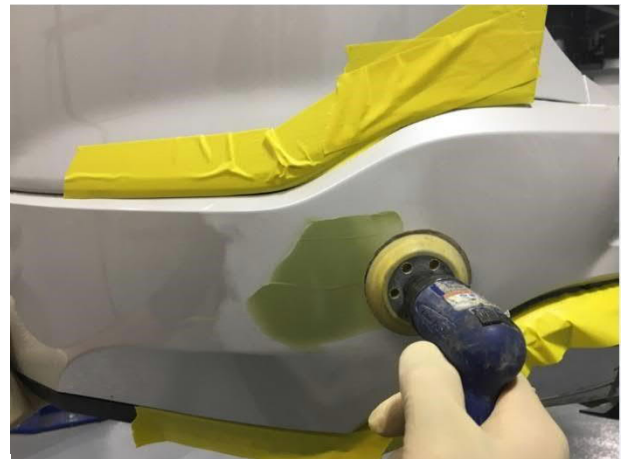
(1) Bumper/Fascia Substrate Damage  
Any Bumper/Fascia equipped with ADAS(s) that requires substrate repair must be replaced. An example of substrate repair is shown in Figure 1.2
