Collision Position Statement

March 9, 2026

BUMPER FASCIA REPAIR WITH ADAS TECHNOLOGY

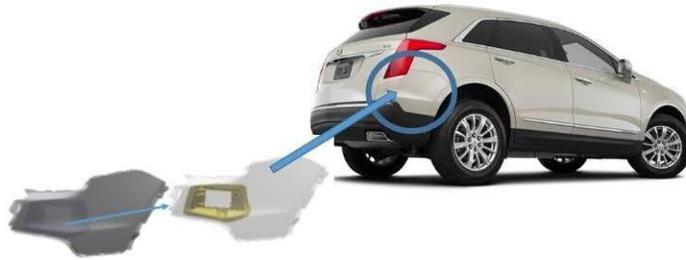
Figure 1.1

Depending on vehicle build configuration, the Bumper/Fascia system may have ADAS sensors attached to the inner surface that are not visible from the exterior of the vehicle (Please refer to Figure 1.1). GM is limiting repairs to these Bumper/Fascia systems on vehicles equipped with ADAS.

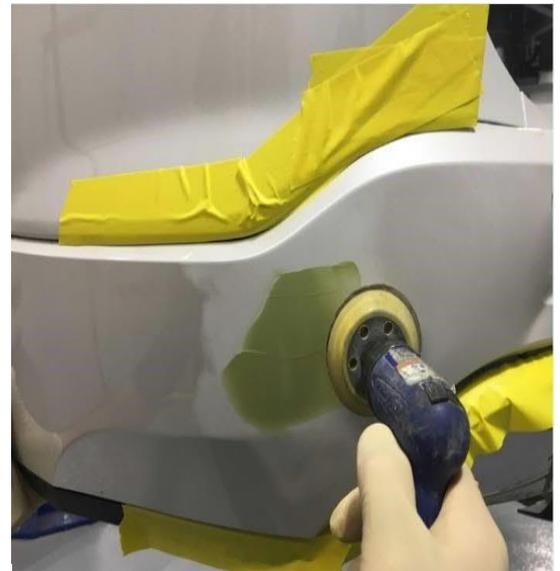
- Bumper/Fascia Substrate Damage_Any Bumper/Fascia equipped with ADAS(s) that requires substrate repair must be replaced.
- An example of substrate repair is shown in Figure 1.2
- Figure 1.2
- Paint Refinish Repairs can be made, provided the repaired portion of the Bumper/Fascia is measured and verified with a mil gauge.

*Total paint thickness on any repair should not exceed 13 mils.

NOTE: A Paint MIL gauge such as the PosiTector 200 by DeFelsko, can determine paint depth.
